Sigma Drive SD55 service report

Vessel: French Connection

Model: Sun Odyssey 37

Engine: Volvo Penta 2040D (40HP)

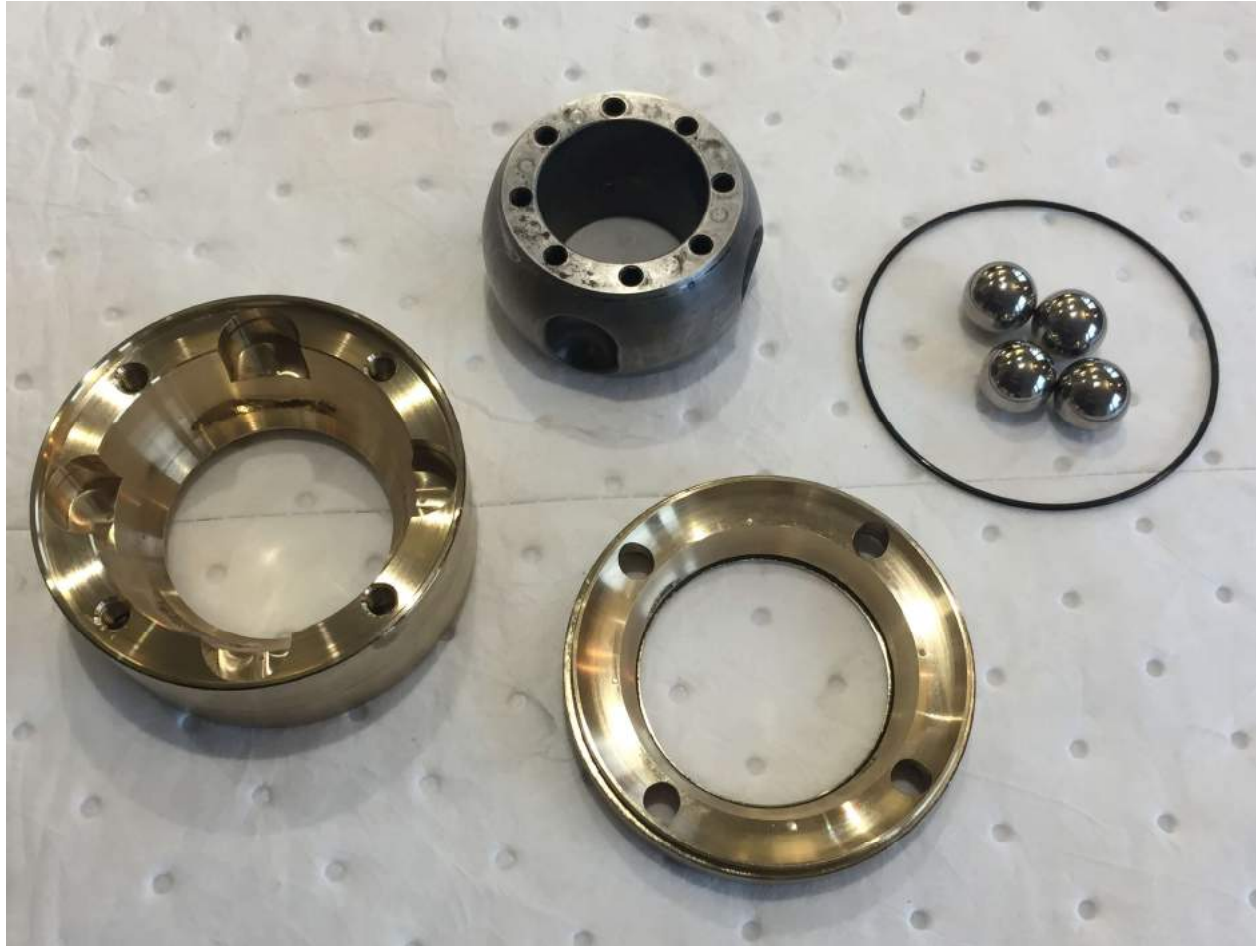
Sigma drive stripped down, cleaned and now ready for inspection

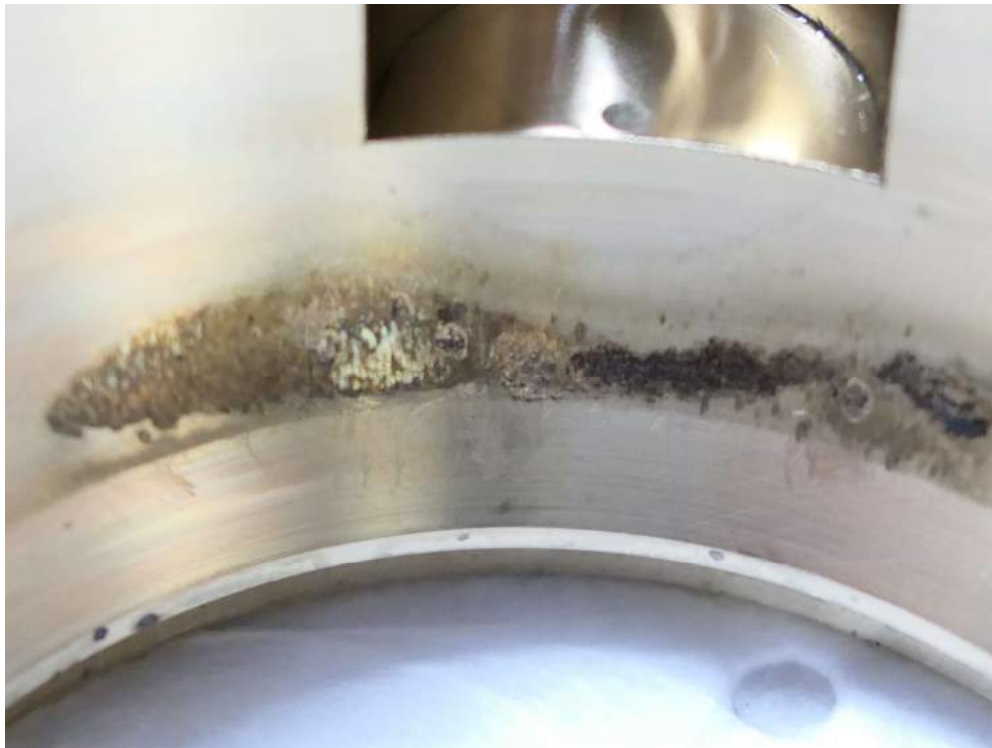
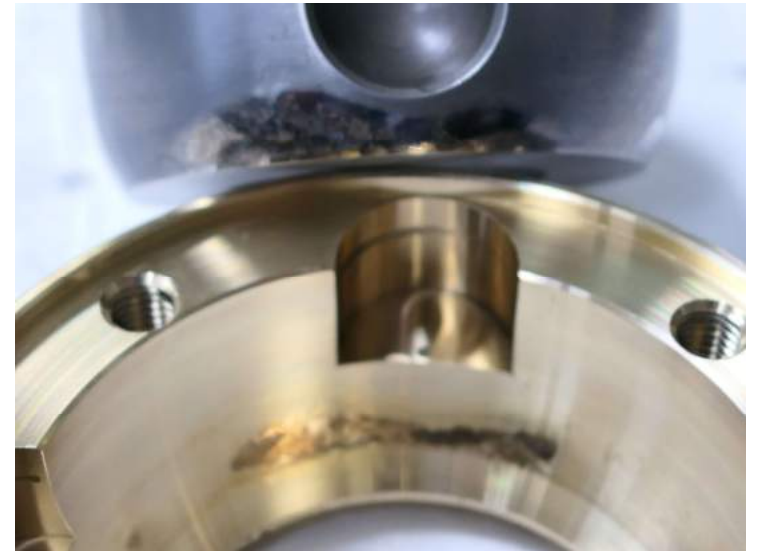
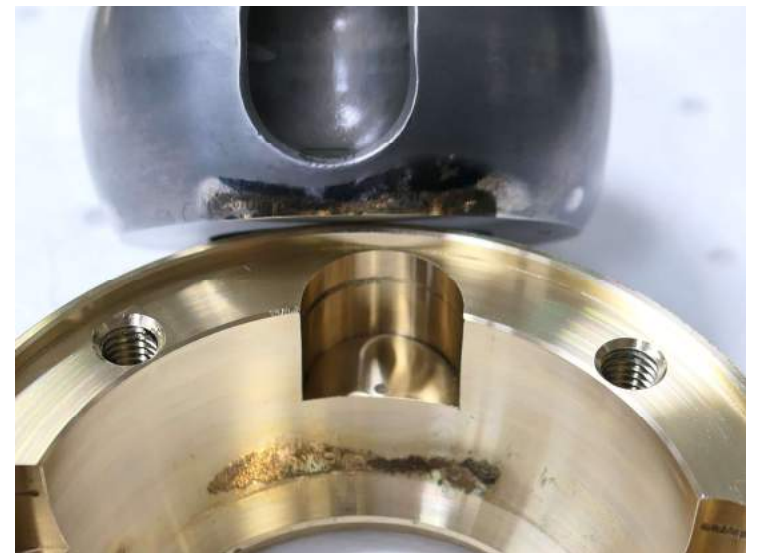
A touch condition between the main corp and the central sphere had occurred

A lot of the touch condition between the main corp and central sphere was superficial. Nearly all of the touch condition marks were easily removed by using a metal polish and a Dremel.

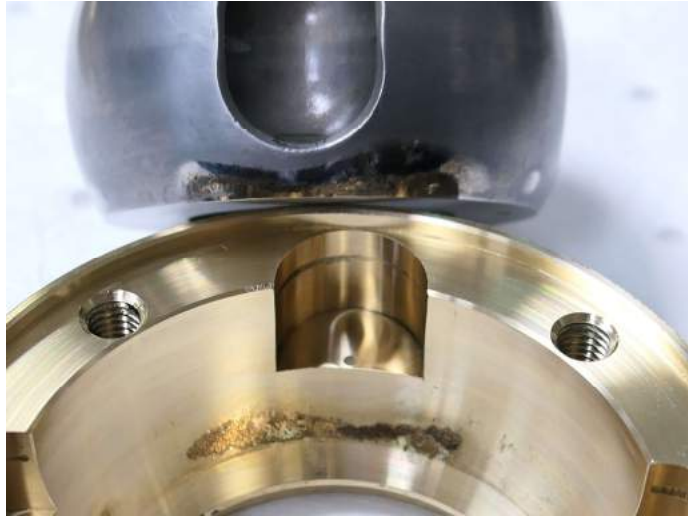
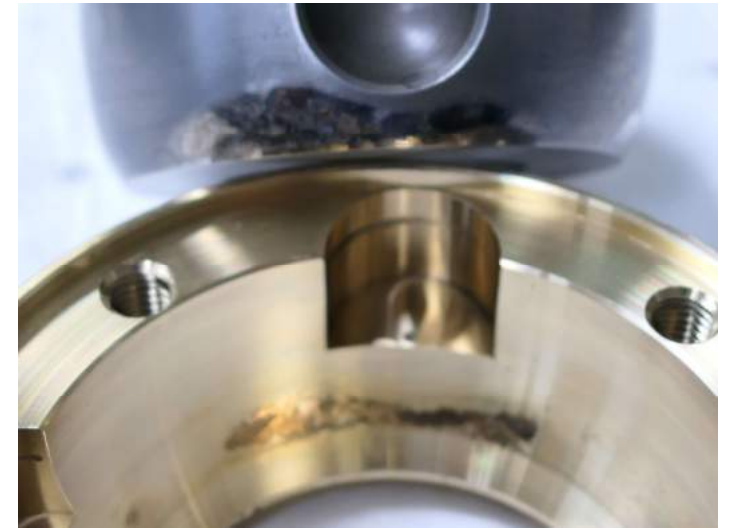
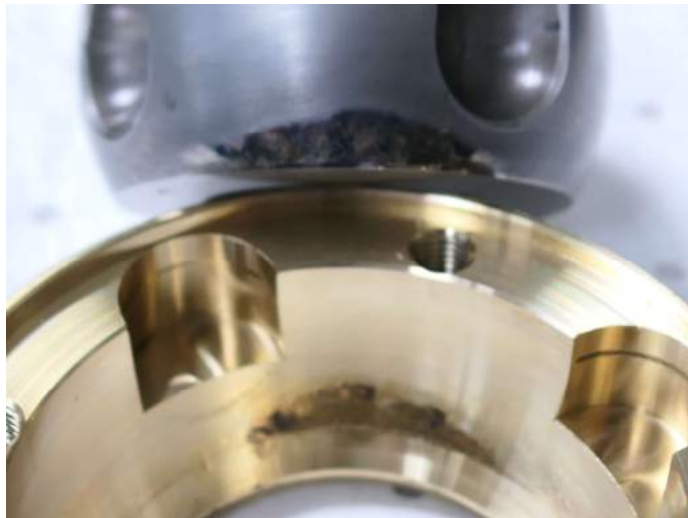
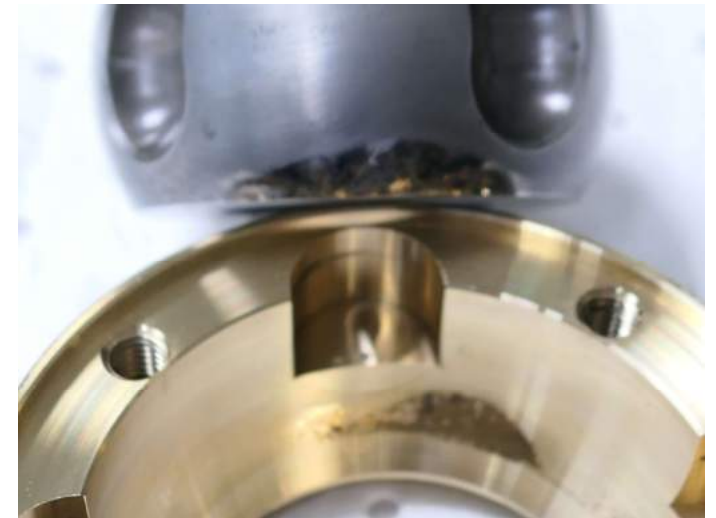
This touch condition
was evident around
Most of the corp and
central sphere

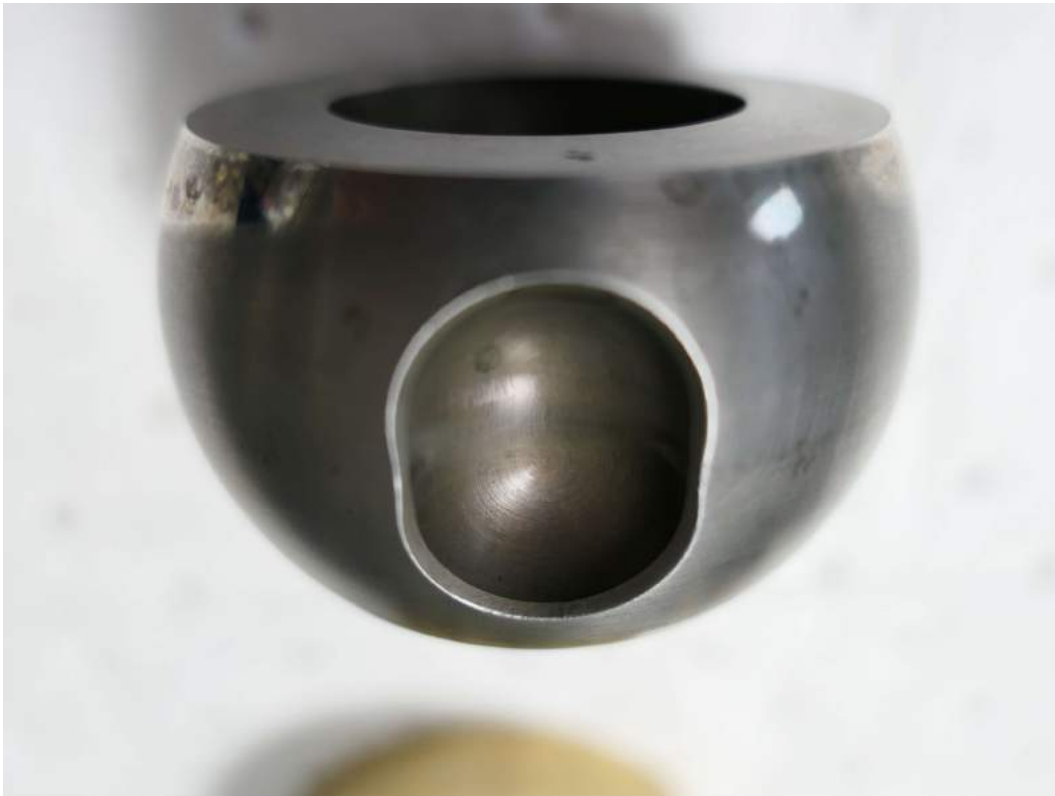
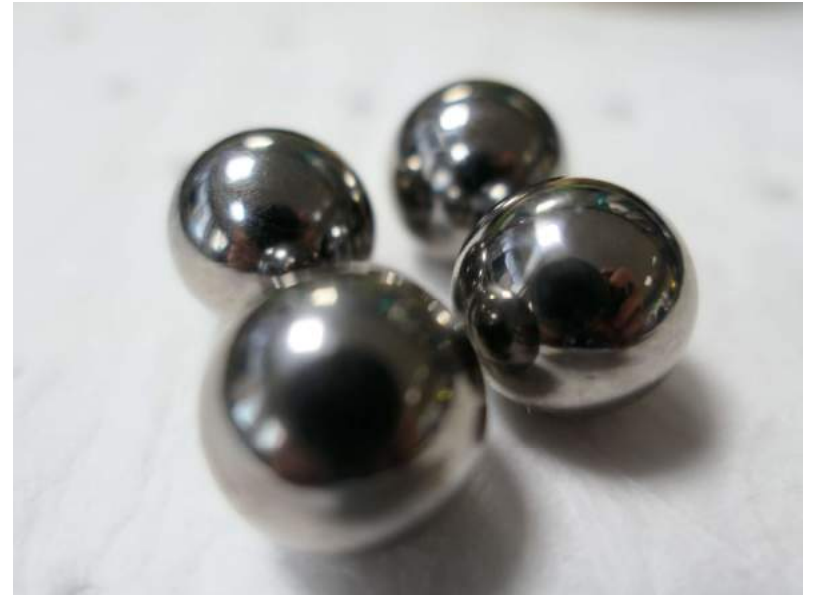
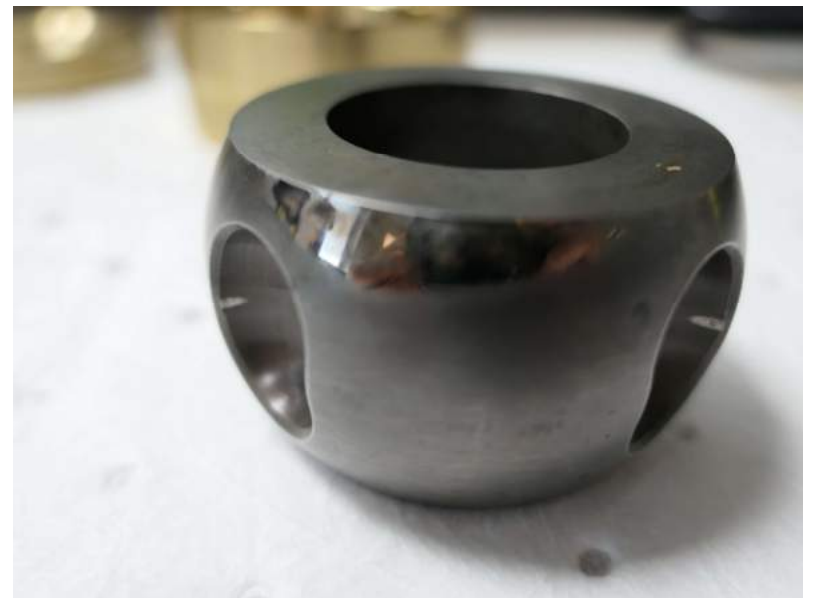
No wear condition found to the ball bearings or bearing wells

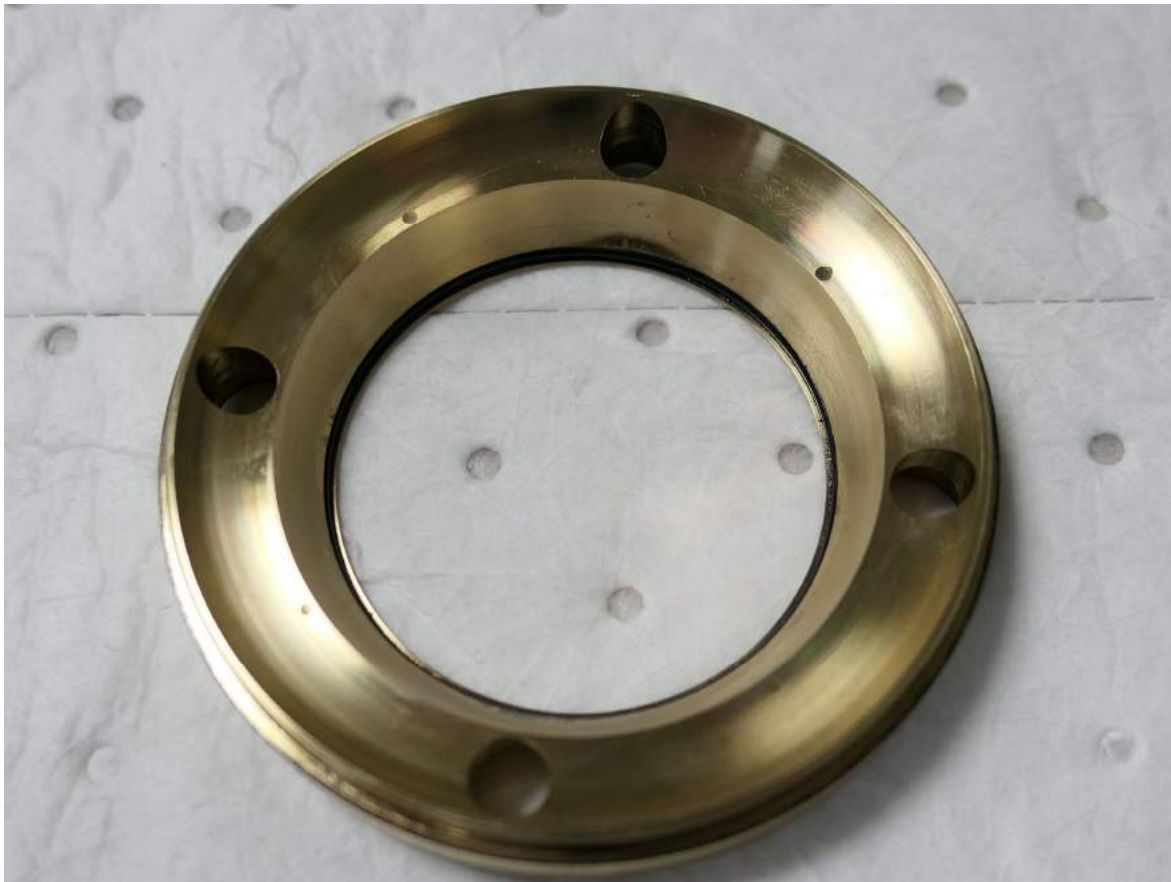
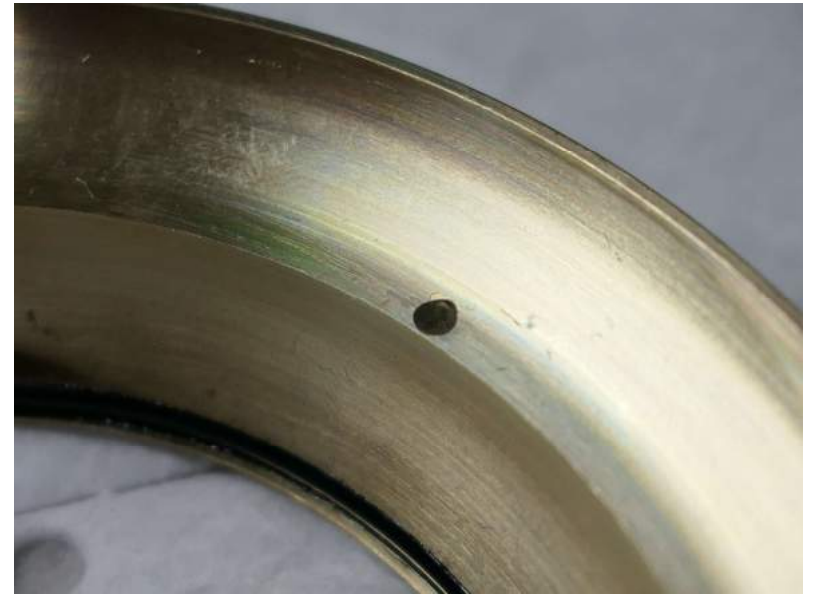
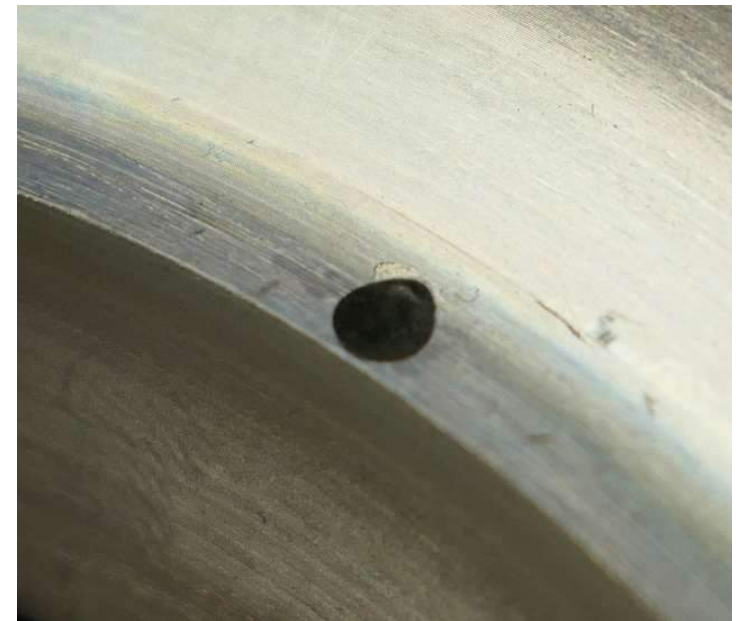
Evidence marks of a wear / touch condition between the ball Bearings and the cover

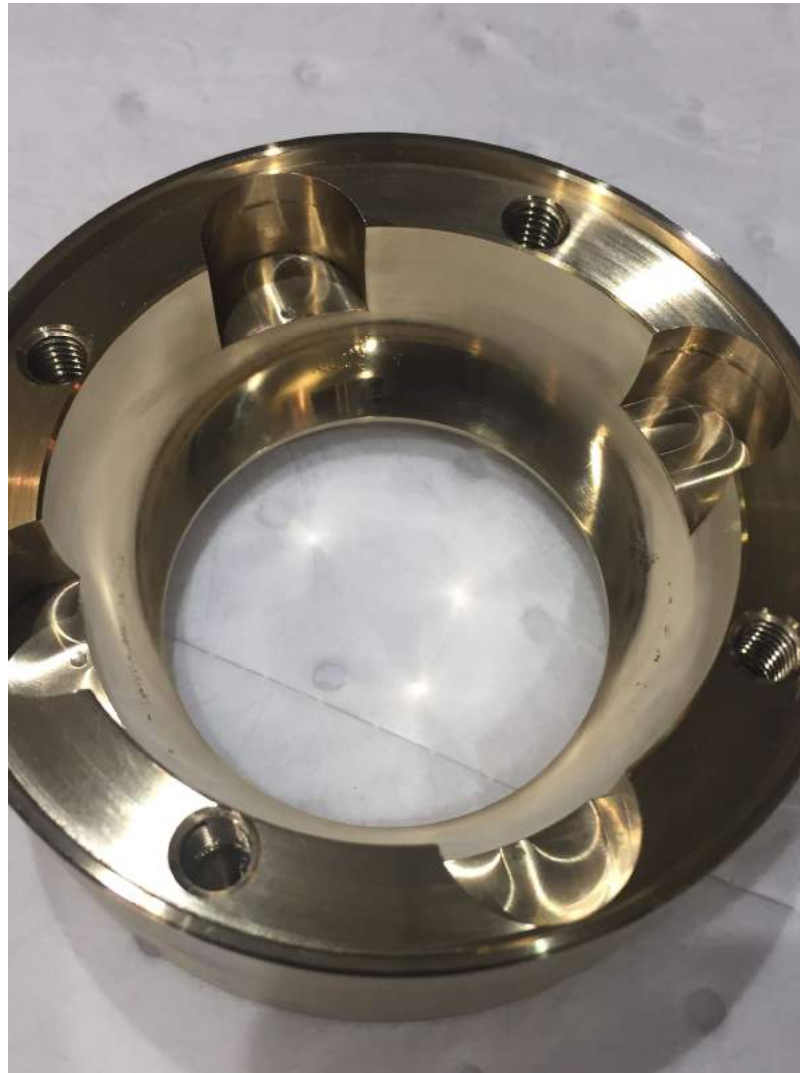
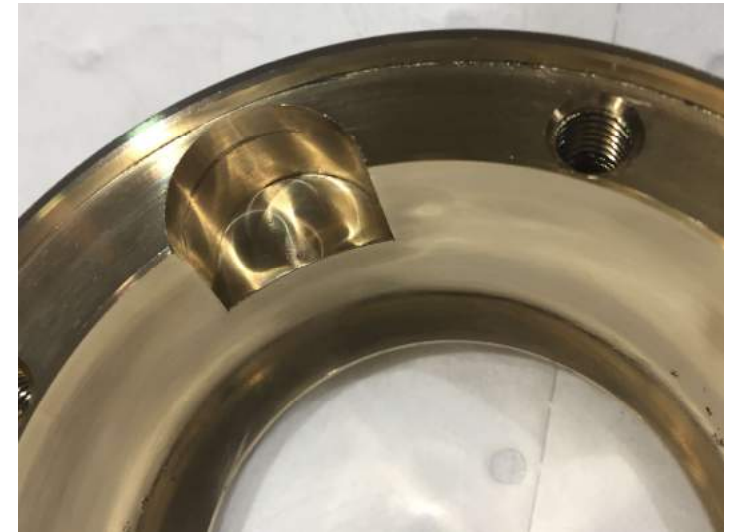
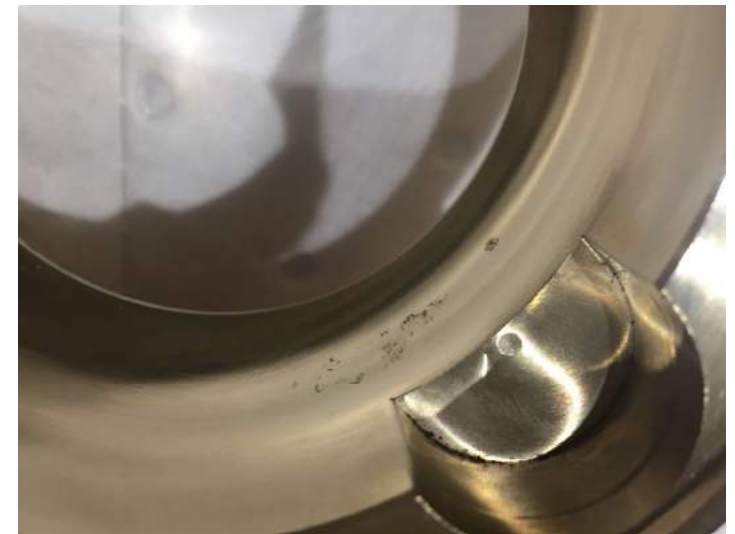
Only very slight pitting remained.

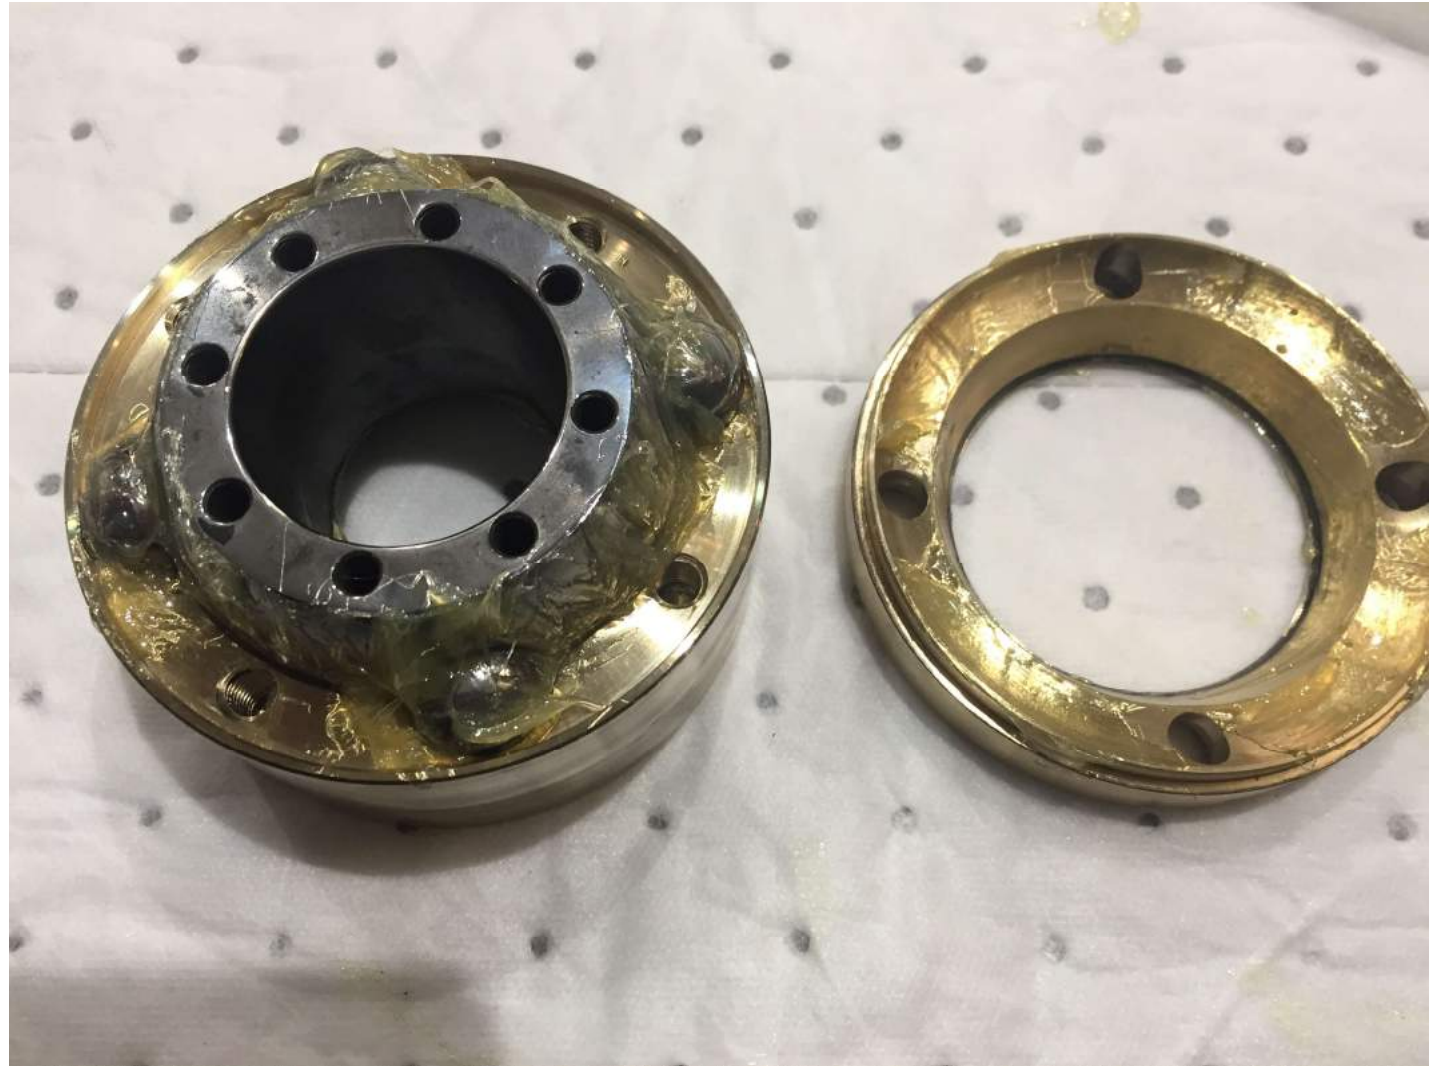
The re-assembly

Trouble free with no area's of concern. I was not shy with the grease!

Before closing the joint I did wipe away the grease form all the threaded holes.

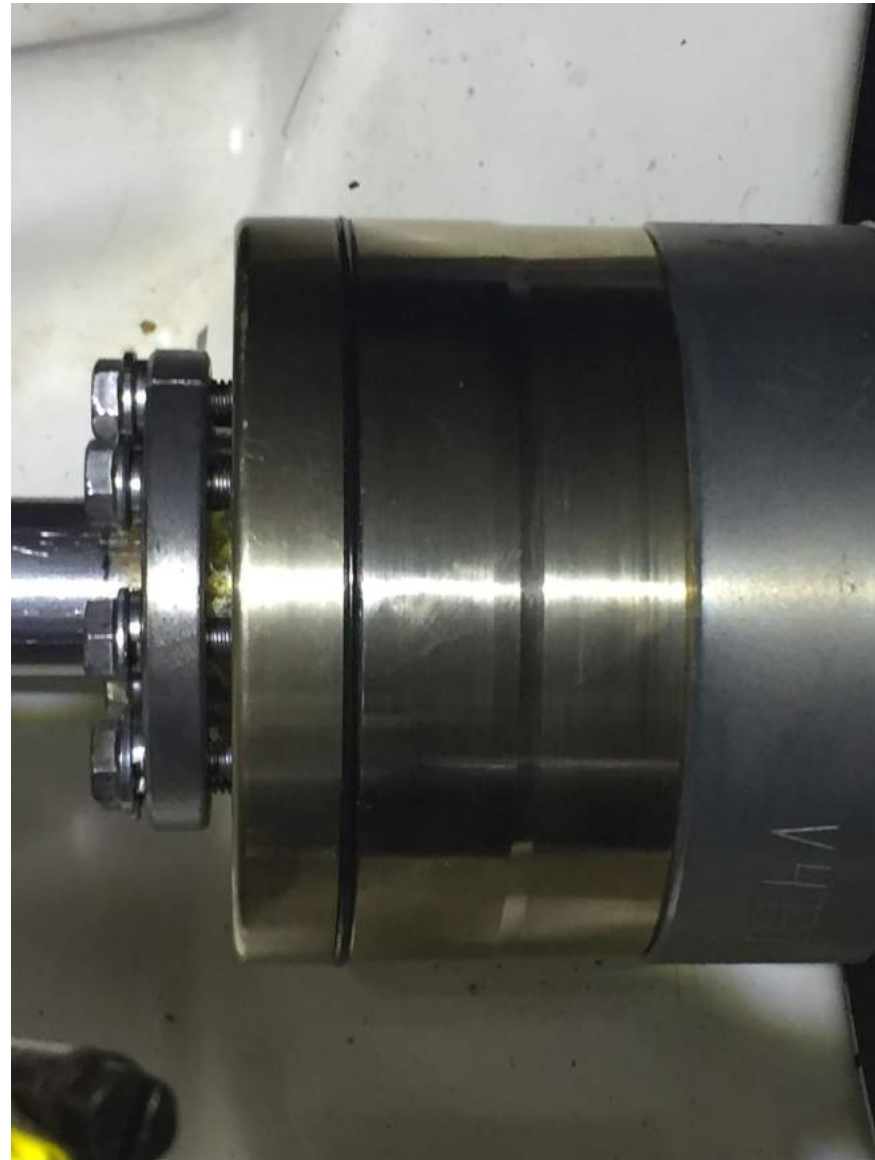
Installation

Sigma drive runs smoothly without any play
Please note: I have not fitted the correct bolts
into the clamp unit. These will be fitted after
initial testing.
